DAM INFORMATION

AC - DAMS

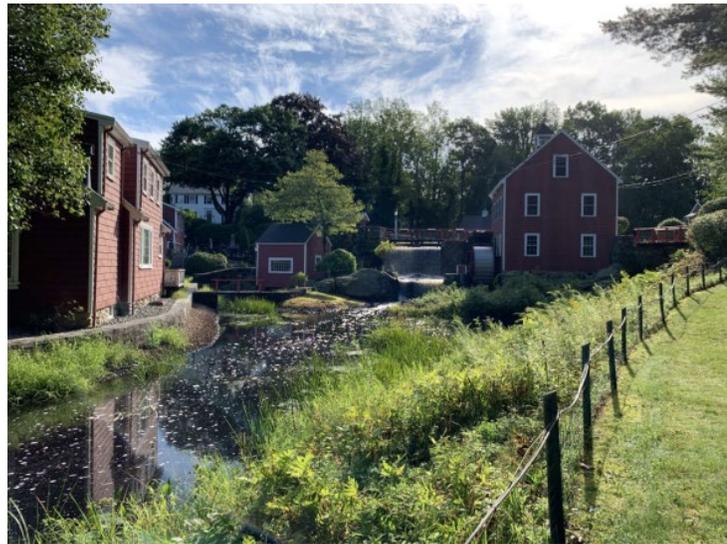
Figure 1: The left and right sluice looking upstream at the Russell Mill Dam.

Water also seeps under the intake structure causing another one to two GPM of leakage. The right sluice way has an estimated five GPM of leakage while in the closed position, and the concrete is

deteriorating. There are some areas of stone displacement causing serious stone voids and rotten tree stumps in the left sluice way that should be removed.

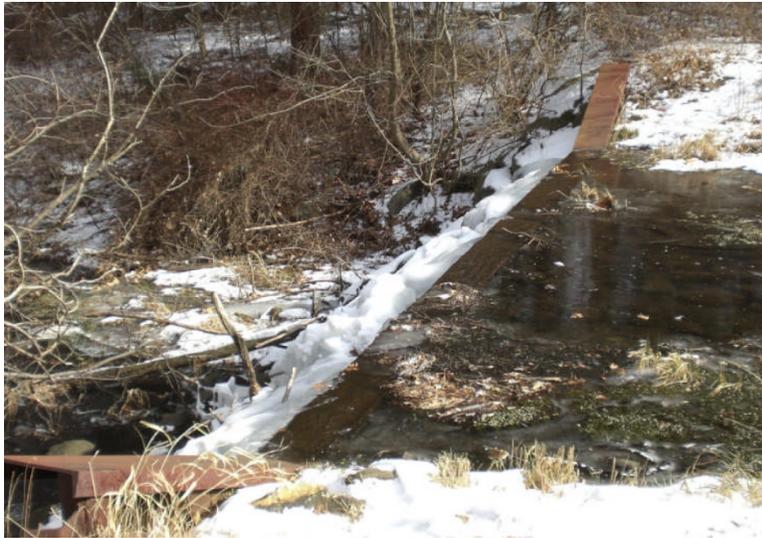
Figure 2: Looking down at the Crooked Springs Dam from the left abutment

Dam is classified as a small dam with a significant hazard potential. The likelihood for overtopping is moderate which could cause roadway flooding at Crooked Spring Road, but it is unlikely that the flood extents would reach any residential properties. Both the downstream culvert under Crooked Spring Road and the stream section were in good condition. The only recommended maintenance related to the culvert was the removal of overgrowth on the headwalls. The adjoining stream segment has some sediment deposition and moderate overgrowth.

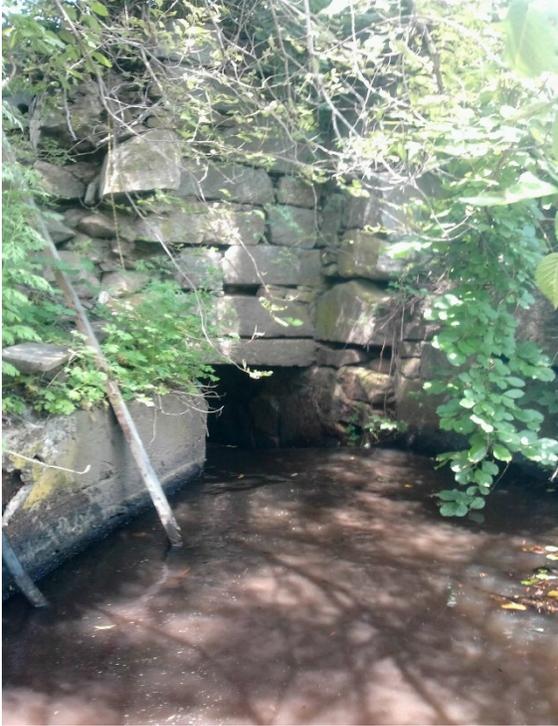
Flow has been known to back up into this area from the Merrimack River during storm events, but no flooding has been recorded. The culvert has partially collapsed wing walls and retaining walls. The culvert and stream have debris and overgrowth.

Figure 3: Looking downstream from the left side of Swains Pond.

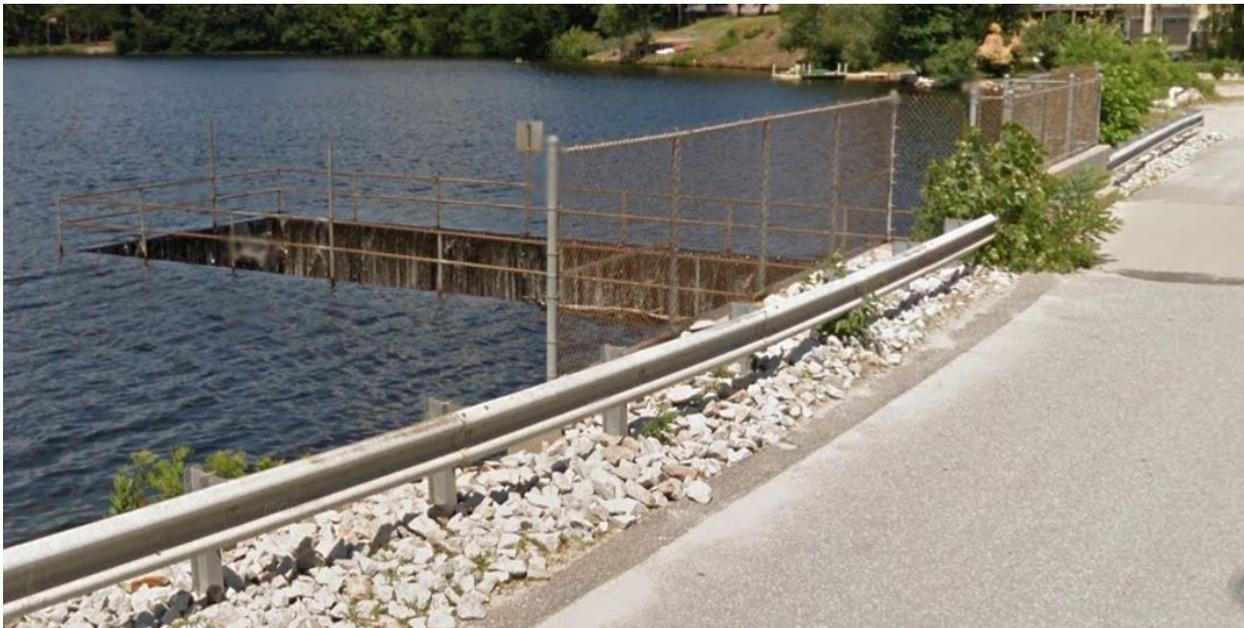
Figure 4: The Broad Crested Weir on Freeman Lake.
